Anchor Diamond Pro® Tall Wall Stands Firm with Proper Soil Improvement

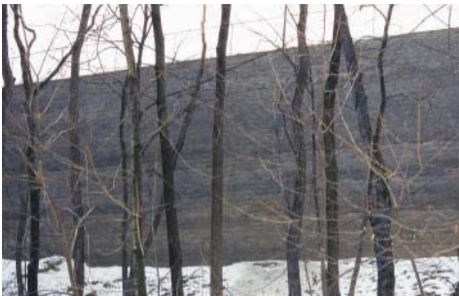
The 42-foot (12.8 meters) high Kline Plaza retaining wall rises through the trees on top of a 1.5 horizontal to 1.0 vertical slope.

SRDI quickly confirmed that the site for the wall, which had been filled in some 20 years ago but never compacted adequately, needed serious help. The solution was to over excavate the soil at the bottom of the wall and replace it with a reinforced mat foundation. The mat consisted of a series of reinforcing fabric layers and soil to create a stable bearing surface capable of supporting the 42-foot (12.8 meters) high wall. SRDI engineers specified Mirafi HS 1000 geotextile with a working strength of 12,000 pounds per

foot (175 kN/m). The geotextile was placed on two-foot (600mm) vertical lifts in the foundation beginning 13 feet (4 meters) below the proposed bottom of the wall. The 13-foot (4 meter) deep mat extended in places 19 feet (5.79 meters) in front of and 26 feet (7.89 meters) behind the wall location to provide adequate global stability and foundation bearing.

The wall itself was constructed using Mirafi 8 XT, 5 XT and 3 XT geogrid placed on 8-to-24 inch (203–700 mm) spacing. Large immovable rock outcrops added to the challenge of placing the reinforcement behind the wall. This required the installers to incorporate the rock with the reinforcement to maintain a cohesive and stable foundation for the retaining wall.
